Applies To: See VEHICLES AFFECTED

April 2004

Safety Recall: Combination Light Switch

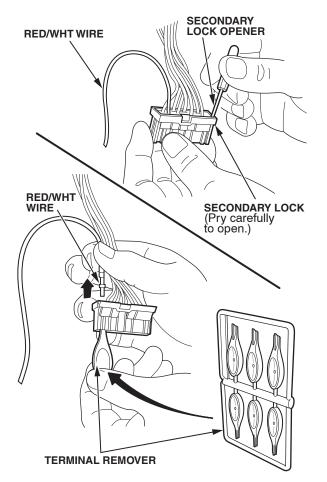
12. Using the secondary lock opener from the Terminal Maintenance Set (T/N 070AZ-S5A-010), carefully pry open the secondary lock on the RED/WHT wire side of the 16P connector.

13. Twist off a terminal remover from the Terminal Remover Set (T/N 070AZ-S5A-011). Insert the terminal remover into the center row cavity of the 16P connector, above the RED/WHT wire cavity, then remove and discard the RED/WHT wire. 14. Strip off 7 mm of insulation from the vehicle wire harness side of the RED/WHT wire. Insert the stripped end into one side of the splice connector, and crimp the connector.
