HONDA Export Service Bulletin 00-003

Applies To: **1996-99 Civic** – ALL **1996-97 CR-V** – ALL June 2000

Growl From A/C Idler Pulley

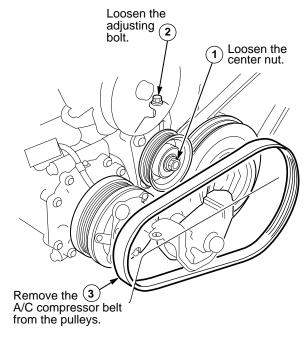
Civic CX, DX, LX, HX, EX:

3. Loosen the idler pulley, then remove the belt and let it hang from the engine mount.

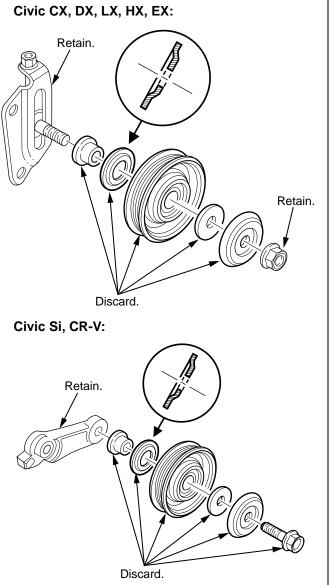
4. Remove the idler pulley assembly, then disassemble it and discard the pulley and the parts shown.

- 5. Assemble the pulley with the parts from the appropriate kit listed under PARTS INFORMATION.
- 6. Reinstall the power steering pump.
- 7. Reinstall the belts, and adjust them to the tension specified in the appropriate shop manual.
