Applies To: **2003 Pilot EX** – KA From VIN 2HKYF18..3H600001 thru 2HKYF18..3H604470
– KX From VIN 2HKYF18..3H900001 thru 2HKYF18..3H901293

March 2004

2003 Pilot: Rear Blower Motor Does Not Work (Supersedes 03-048, dated October 2003)

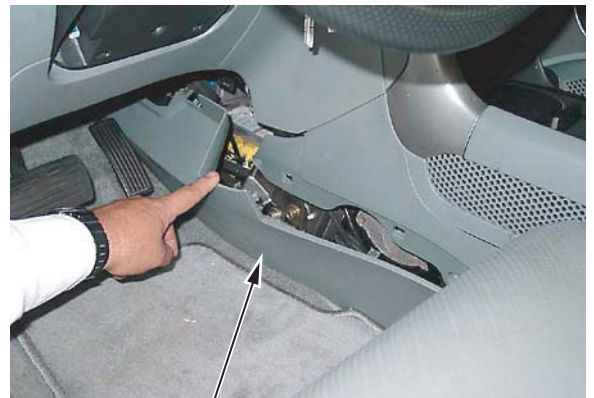
DRIVER'S CONSOLE SIDE TRIM

1. Turn the ignition switch to LOCK (0), and remove the key.
2. Move the driver's seat all the way back.
3. Remove the driver's console side trim by pulling it out at the front to pop out the clips and release the two tabs.

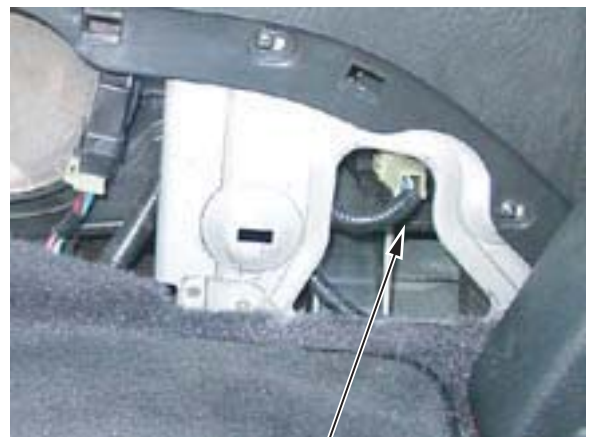
REAR POWER TRANSISTOR
WIRE HARNESS CONNECTOR

4. While wearing protective gloves, reach through the opening in the center console frame, and disconnect the wire harness from the rear power transistor.

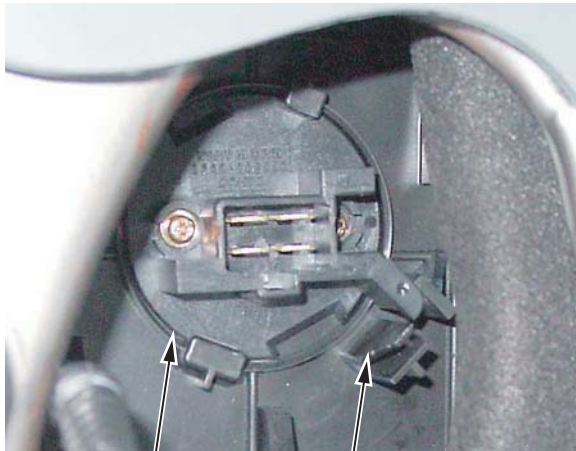
REAR POWER TRANSISTOR LOCK TAB

5. Locate the lock tab release at the bottom of the transistor. Push the lock tab down and toward the rear, then turn the power transistor clockwise past the lock tab.

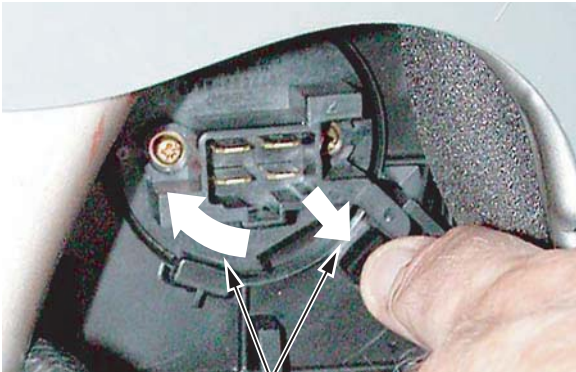
Push the lock tab down, then rotate the transistor clockwise.

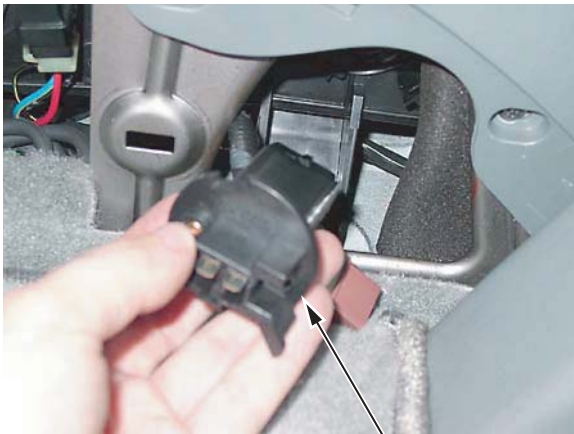
REAR POWER TRANSISTOR

6. Pull out the power transistor.

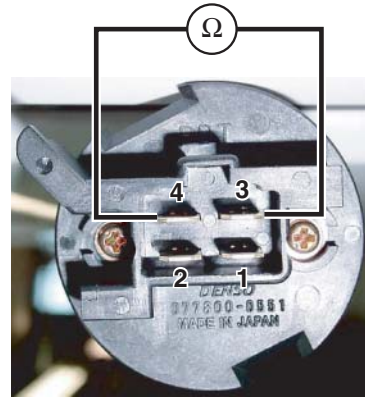
7. Check the resistance between pins 3 and 4.

Is the resistance more than 1MΩ (1,000,000 ohms)?

YES — Replace the power transistor (go to REPAIR PROCEDURE).

NO — This service bulletin does not apply. Test the blower motor system for other possible causes (refer to the A/C section of the 2003 Pilot Shop Manual).

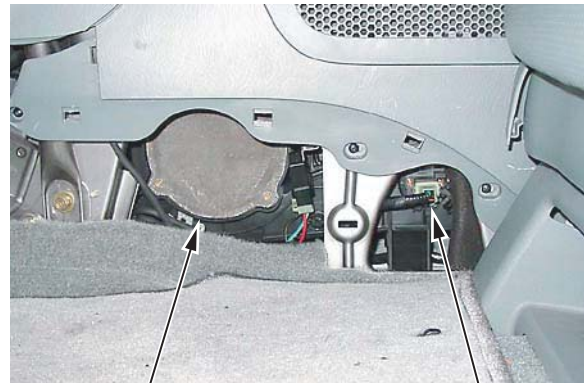
REAR POWER TRANSISTOR

BLOWER INTAKE SCREEN
(Vacuum clean.)

1. Install a new power transistor into position, and turn it counterclockwise past the lock tab. Make sure the transistor locks firmly into place.

2. Reconnect the wire harness.
3. Clean the blower intake screen by vacuuming it.
4. Reinstall the driver's side console trim. Insert the front tab first, then reconnect the clips by lightly tapping the trim into place.
5. Insert the key, and turn the ignition switch to ON (II).
6. Press the AUTO button on the front climate control panel twice. Check that FULL AUTO is displayed.
7. Turn the temperature control dial clockwise until 15°C is displayed.
