Applies To: **2003 Pilot EX** – KA From VIN 2HKYF18..3H600001 thru 2HKYF18..3H604470  
– KX From VIN 2HKYF18..3H900001 thru 2HKYF18..3H901293

**March 2004**

## 2003 Pilot: Rear Blower Motor Does Not Work (Supersedes 03-048, dated October 2003)

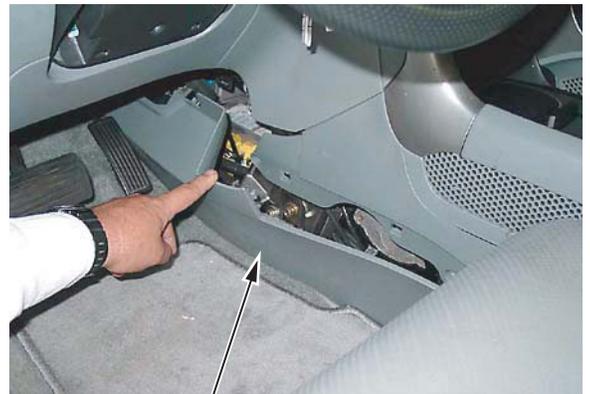
DRIVER'S CONSOLE SIDE TRIM

1. Turn the ignition switch to LOCK (0), and remove the key.
2. Move the driver's seat all the way back.
3. Remove the driver's console side trim by pulling it out at the front to pop out the clips and release the two tabs.

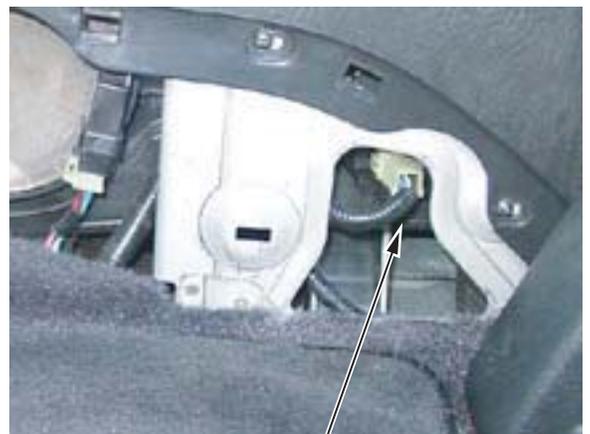
REAR POWER TRANSISTOR  
WIRE HARNESS CONNECTOR

4. While wearing protective gloves, reach through the opening in the center console frame, and disconnect the wire harness from the rear power transistor.

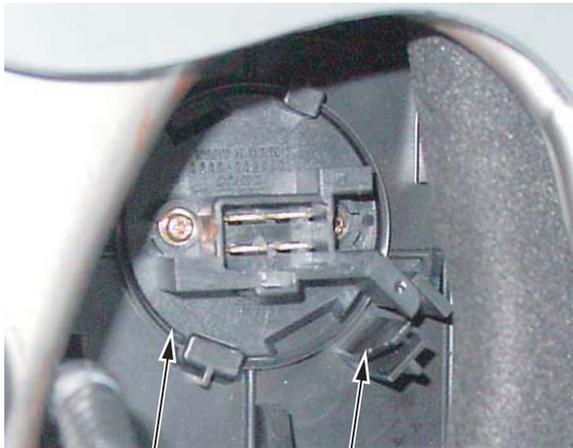
REAR POWER TRANSISTOR      LOCK TAB

5. Locate the lock tab release at the bottom of the transistor. Push the lock tab down and toward the rear, then turn the power transistor clockwise past the lock tab.

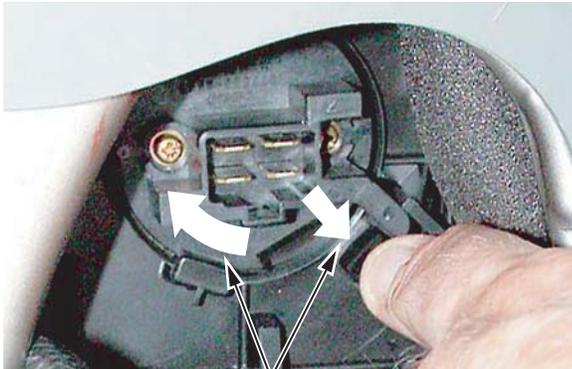
Push the lock tab down, then rotate the transistor clockwise.

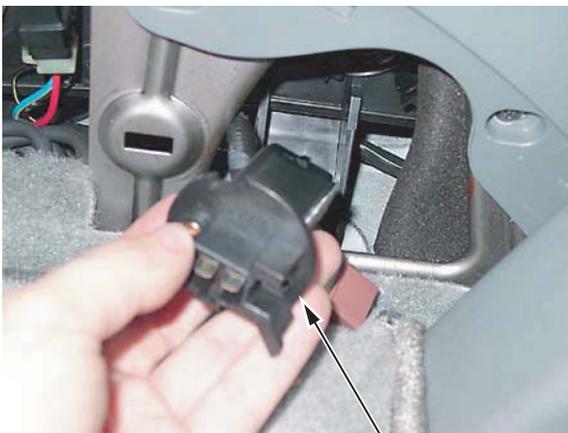
REAR POWER TRANSISTOR

6. Pull out the power transistor.

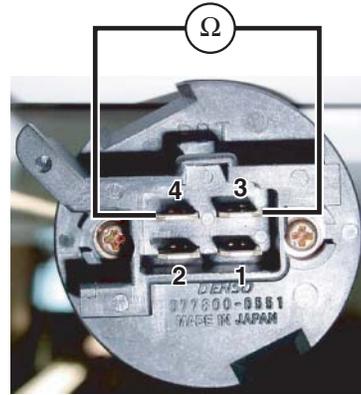
The power transistor for the rear blower has an open circuit.

7. Check the resistance between pins 3 and 4.

Is the resistance more than  $1M\Omega$  (1,000,000 ohms)?

**YES** — Replace the power transistor (go to REPAIR PROCEDURE).

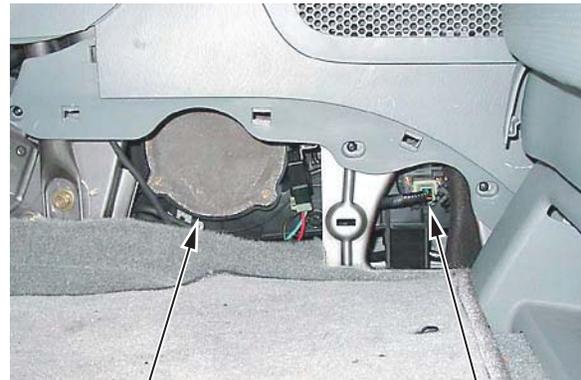
BLOWER INTAKE SCREEN  
(Vacuum clean.)

REAR POWER TRANSISTOR

1. Install a new power transistor into position, and turn it counterclockwise past the lock tab. Make sure the transistor locks firmly into place.

2. Reconnect the wire harness.
3. Clean the blower intake screen by vacuuming it.
4. Reinstall the driver's side console trim. Insert the front tab first, then reconnect the clips by lightly tapping the trim into place.
5. Insert the key, and turn the ignition switch to ON (II).
6. Press the AUTO button on the front climate control panel twice. Check that FULL AUTO is displayed.
7. Turn the temperature control dial clockwise until  $15^{\circ}\text{C}$  is displayed.
