Applies To: **2003 Pilot EX** – KA From VIN 2HKYF18..3H600001 thru 2HKYF18...3H604470  
– KX From VIN 2HKYF18..3H900001 thru 2HKYF18...3H901293

October 2003

## 2003 Pilot: Rear Blower Motor Does Not Work

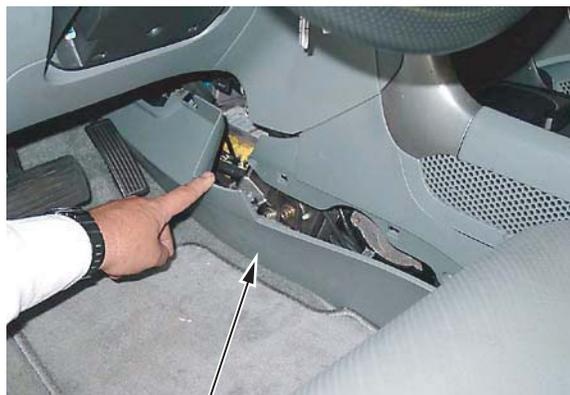
DRIVER'S CONSOLE SIDE TRIM

1. Turn the ignition switch to LOCK (0), and remove the key.
2. Move the driver's seat all the way back.
3. Remove the driver's console side trim by pulling out at the front, to pop out the clips, and to release the two tabs.

2. Reconnect the wire harness.
3. Clean the blower intake screen by vacuuming it.
4. Reinstall the driver's side console trim. Insert the front tab first, then reconnect the clips by lightly tapping the trim into place.
5. Insert the key, and turn the ignition switch to ON (II).

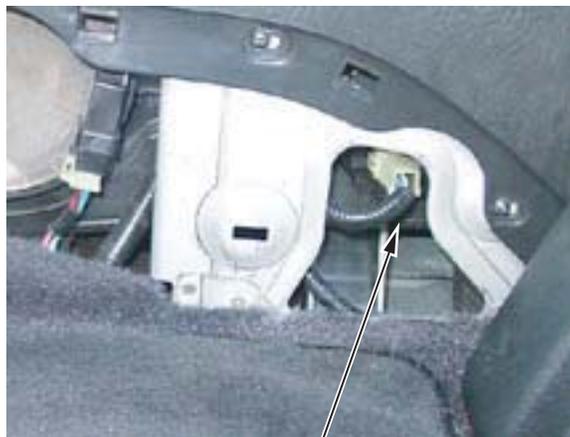
REAR POWER TRANSISTOR  
WIRE HARNESS CONNECTOR

4. While wearing protective gloves, reach through the opening in the center console frame, and disconnect the wire harness from the rear power transistor.

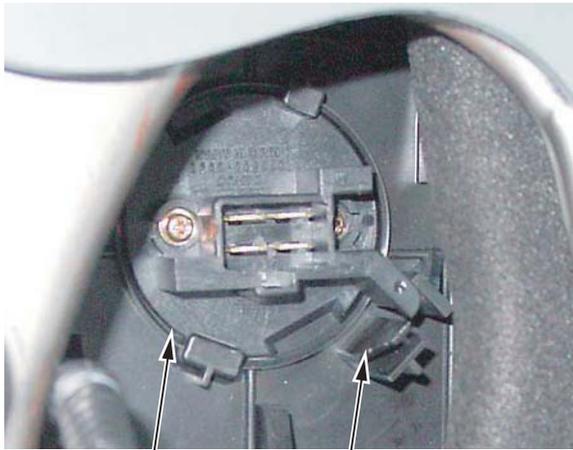
REAR POWER TRANSISTOR      LOCK TAB

5. Locate the lock tab release at the bottom of the transistor. Push the lock tab down and toward the rear, then turn the power transistor clockwise past the lock tab.

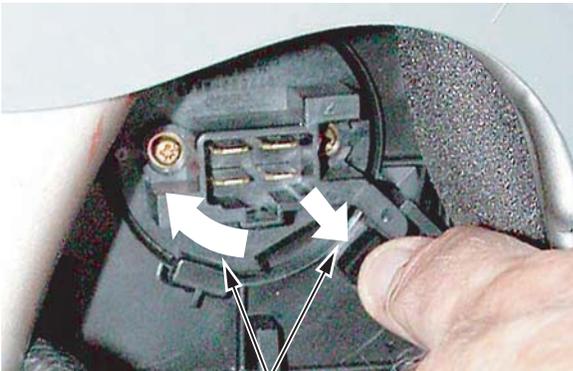
Push the lock tab down, then rotate the transistor clockwise.

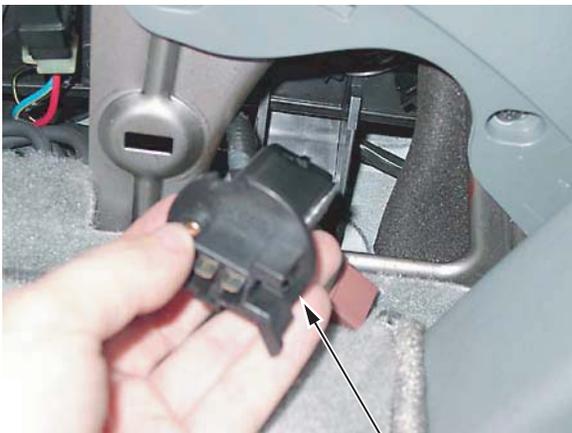
REAR POWER TRANSISTOR

The power transistor for the rear blower has an open circuit.

6. Pull out the power transistor.

Replace the power transistor.

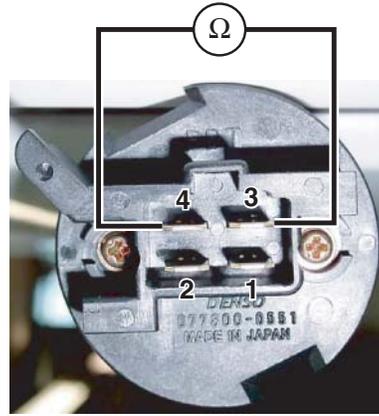
7. Check the resistance between pins 3 and 4.

Is the resistance more than  $1M\Omega$  (1,000,000 ohms)?

**YES** — Replace the power transistor (go to REPAIR PROCEDURE).

**NO** — This service bulletin does not apply. Test the blower motor system for other possible causes (refer to the A/C section of the 2003 Pilot Shop Manual).

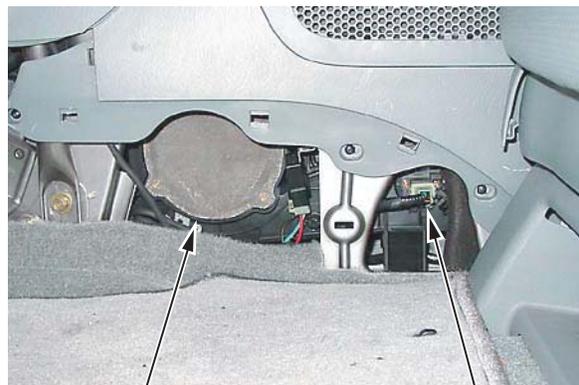
BLOWER INTAKE SCREEN  
(Vacuum clean.)

REAR POWER TRANSISTOR

1. Install a new power transistor into position, and turn it counterclockwise past the lock tab. Make sure the transistor locks firmly into place.
